REPORT

**Thermographic Review of the
Bradley Berneche Home/EcoTerra
Home near Magog, Québec**

Mr. Pierre Couture
National Sales and Marketing Manager
BASF Spray Polyurethane Products
162 Barr Street
St. Laurent, Quebec H4T 1Y4

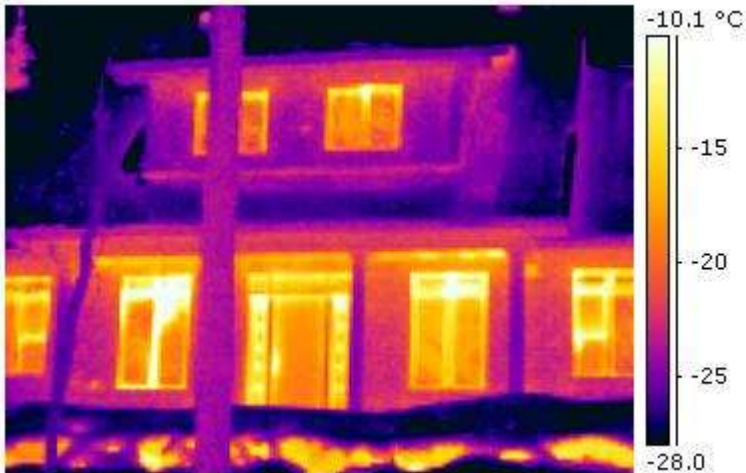
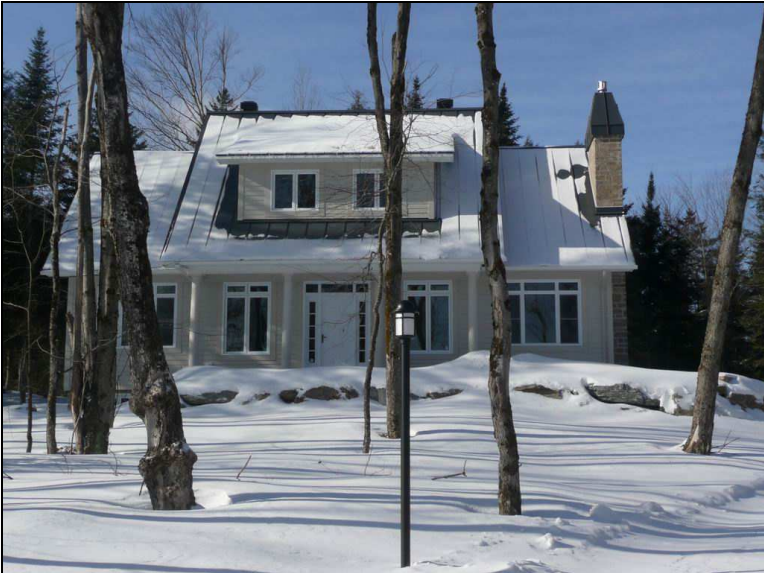
<p>Thermographic Image A1</p>

<p>Remarks</p>	<p>Overall view of front (east) elevation.</p>

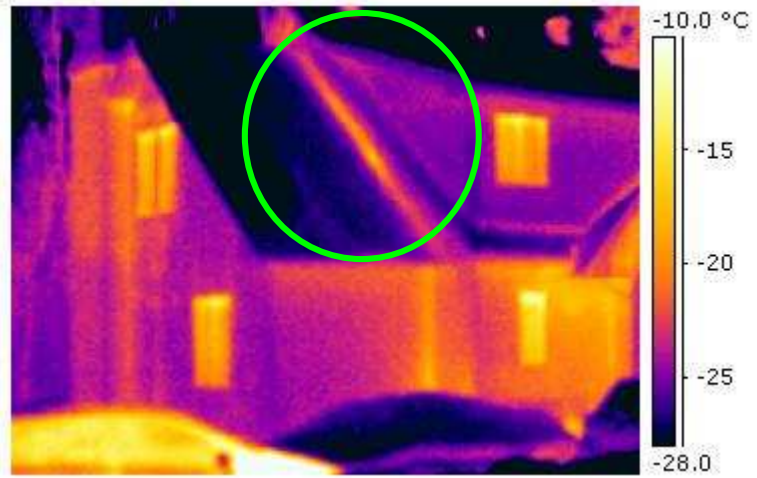
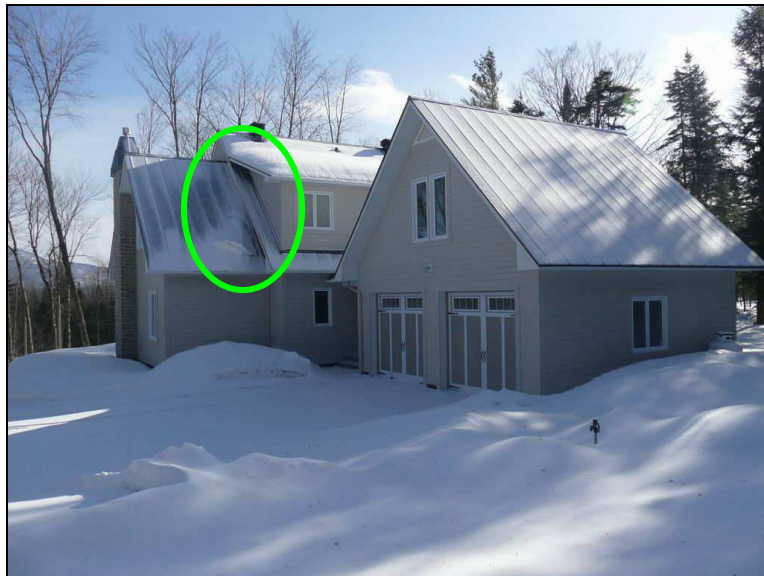
Thermographic
Image A2

The thermal anomalies along the roof/wall intersections (thermographic images A2 and A9) are believed to be typical of this type of detail in conventional construction.

Of note is that a thermal anomaly is clearly visible on one side of the roof intersection at the dormer (thermographic image A9) while it is not visible at the similar detail on the other side of the dormer (thermographic image A2).

North elevation – thermal anomaly observed at roof/wall intersection.

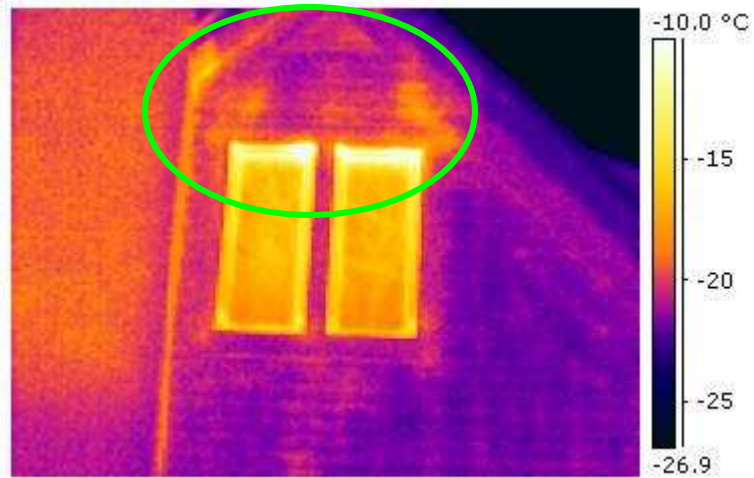
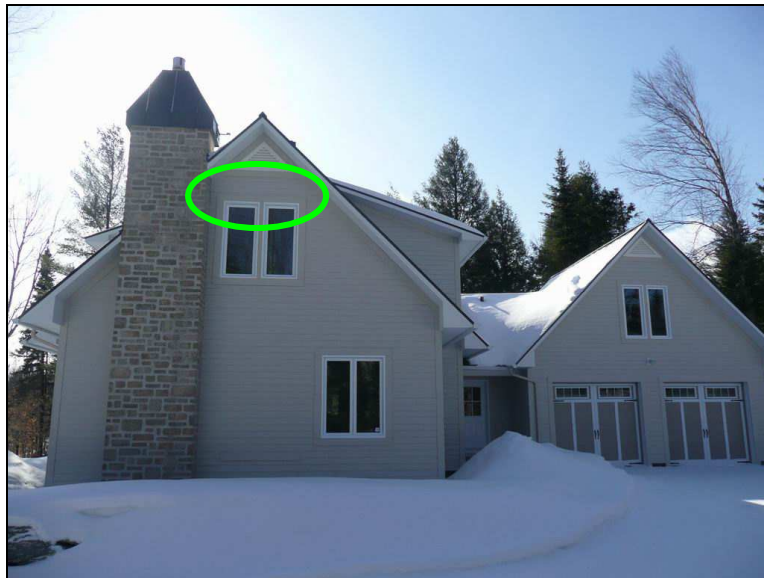
Thermographic
Image A3

Anomalies immediately adjacent to windows may be related to the installation of spray foam between the window frame and the rough opening (thermographic images A3 and A7).

North elevation – possible air leakage observed at top corners of window.

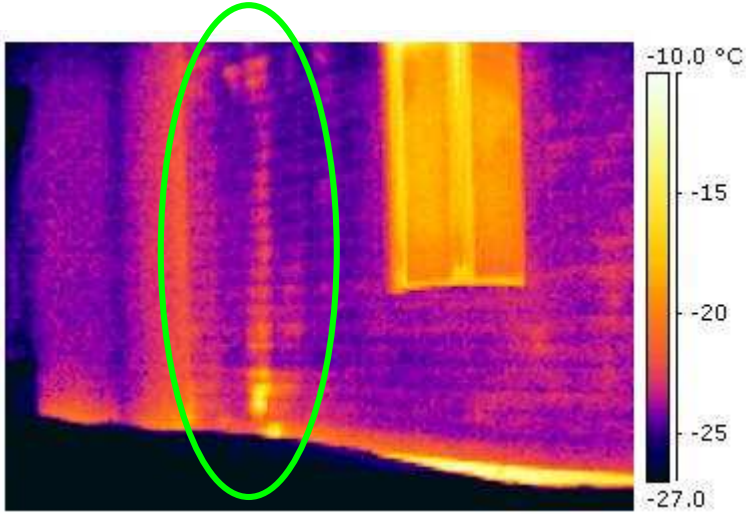
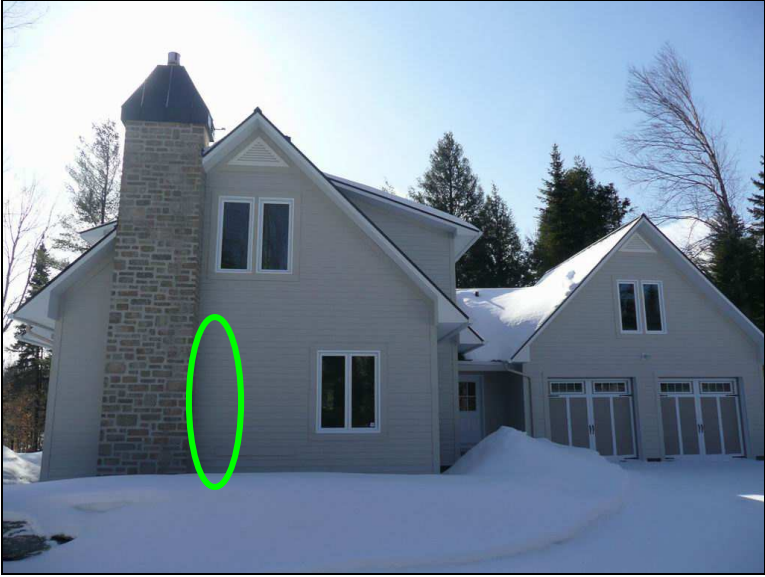
<p>Thermographic Image A4</p>

The cause of the thermal anomalies either side of the chimney and the mottled patterns on the south elevation are unknown.

<p>Remarks</p>	<p>North elevation – thermal anomaly observed on right side of chimney.</p>

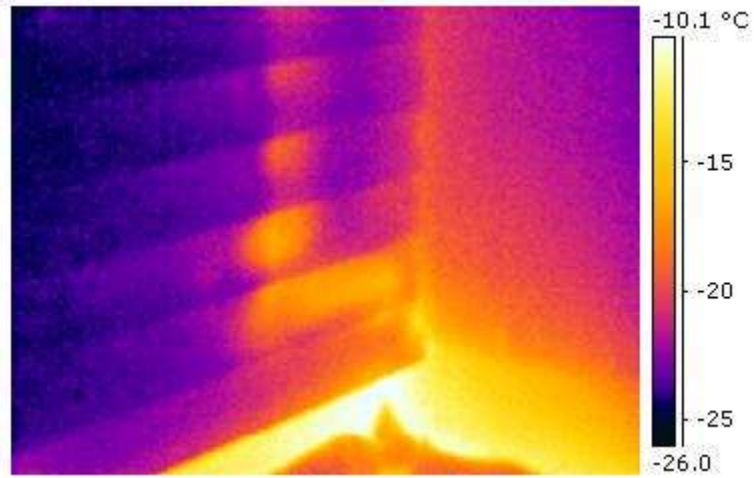
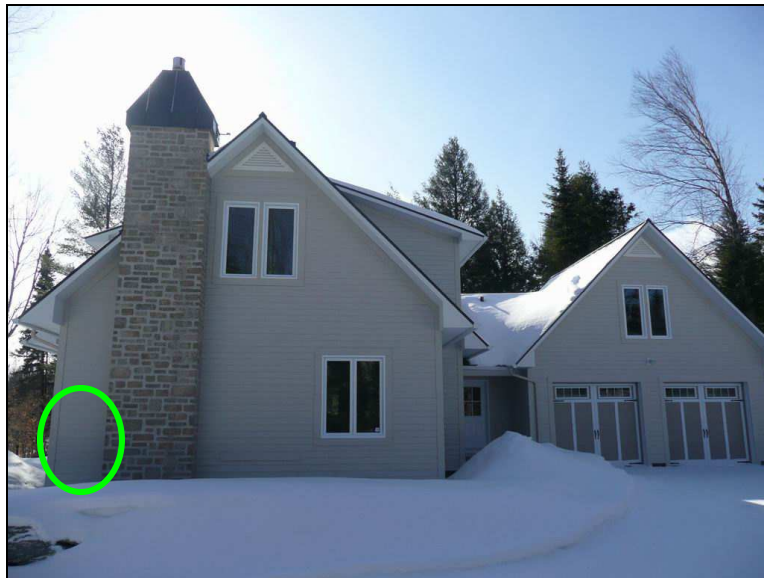
Thermographic
Image A5

North elevation – thermal anomaly observed on left side of chimney.

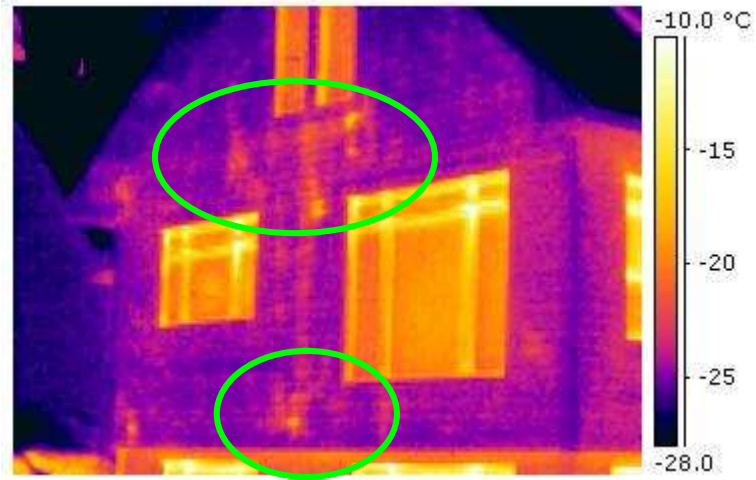
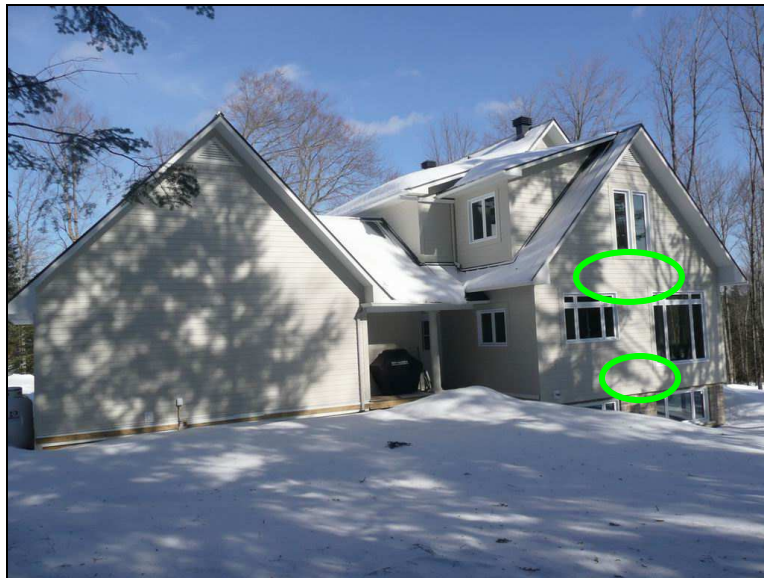
Thermographic
Image A6

South elevation – Thermal anomalies below second floor window and above foundation wall.

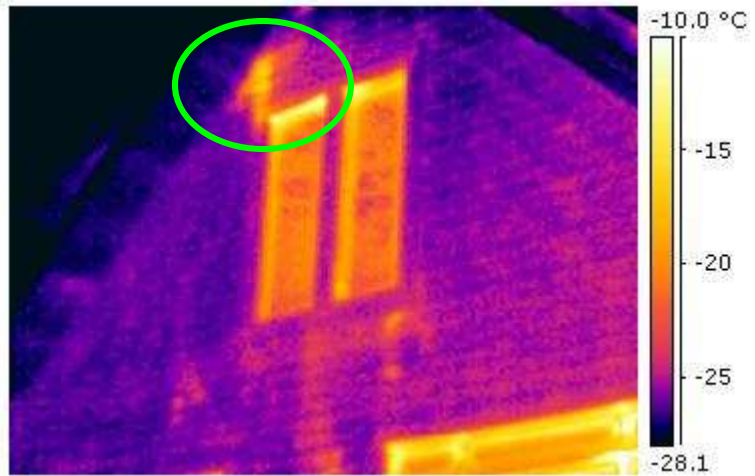
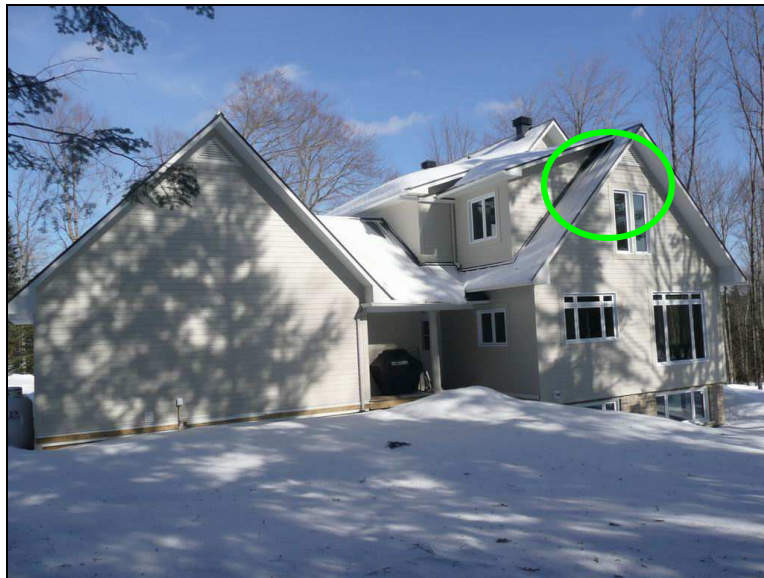
Thermographic
Image A7

South elevation - suspected air leakage above second floor window.

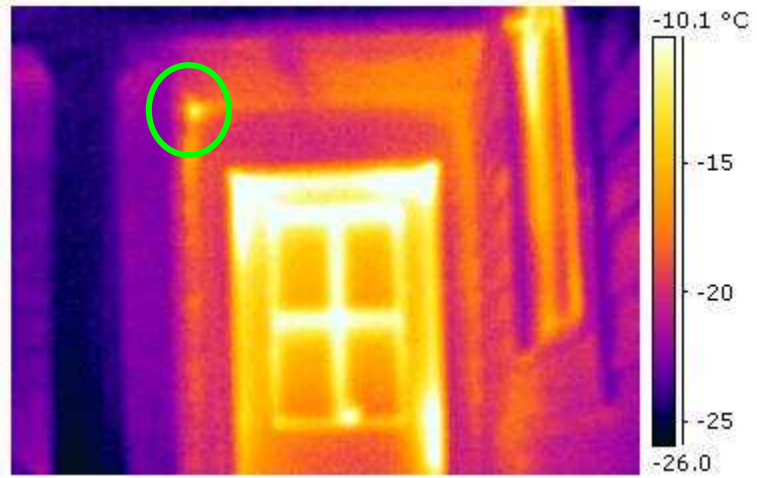
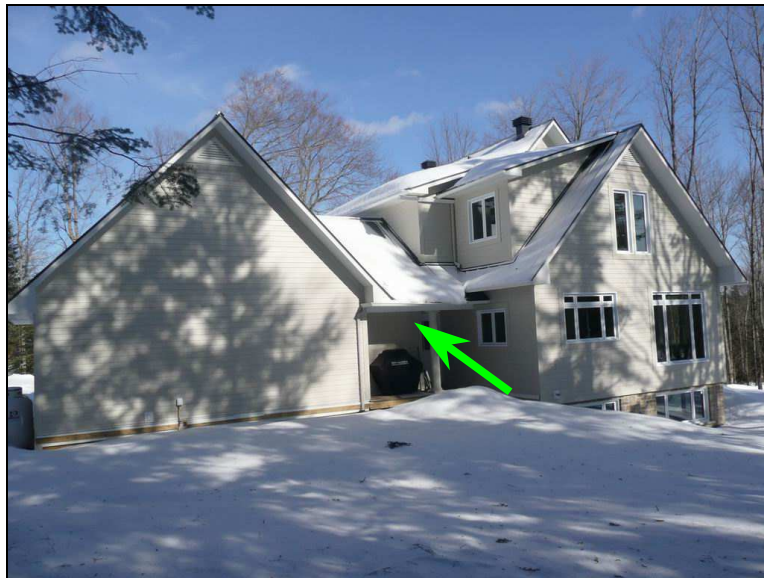
Thermographic
Image A8

South elevation – Suspected air leakage at wall/soffit interface.

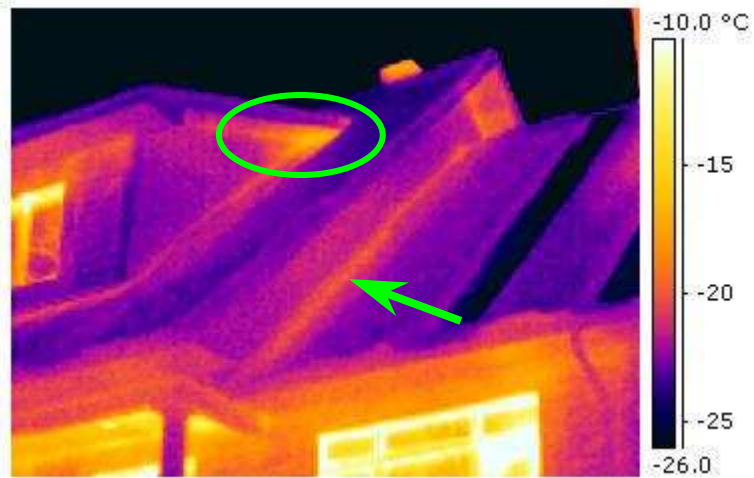
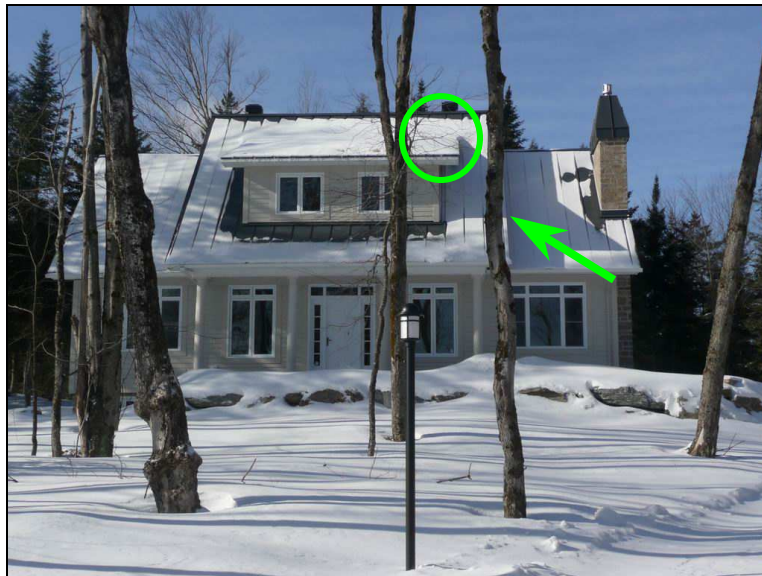
Thermographic Image A9

East elevation – suspected air leakage at roof intersection and thermal anomaly at roof/wall interface.

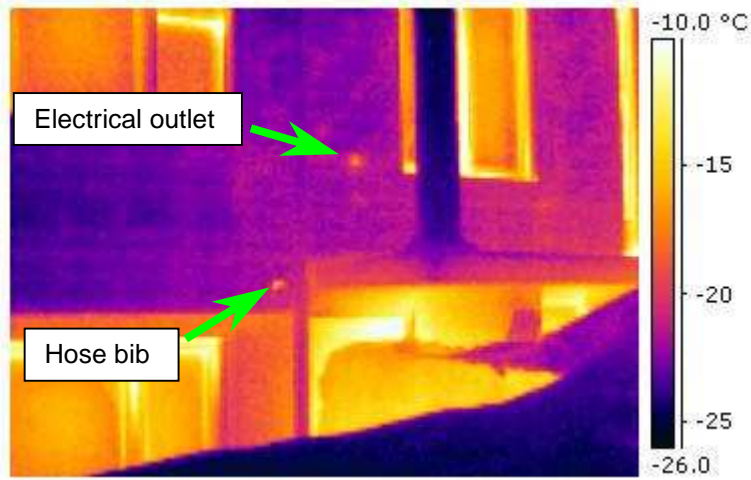
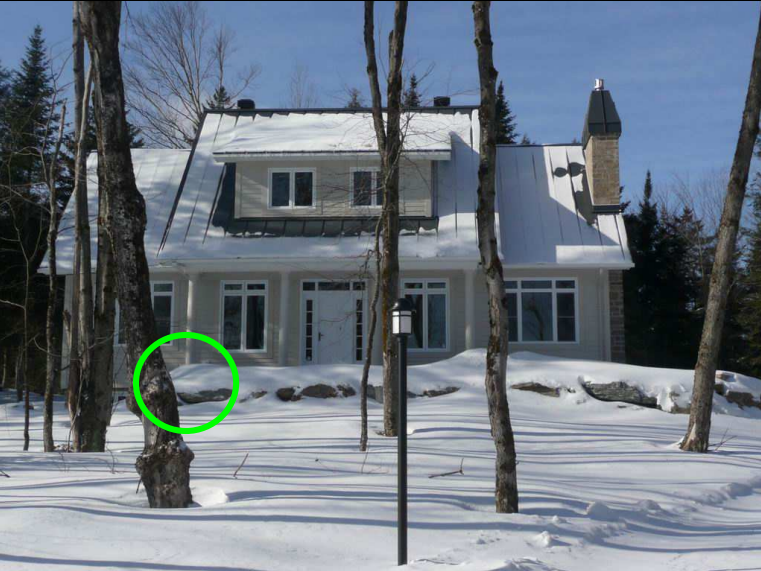
<p>Thermographic Image A10</p>

<p>The daylight photo shows a two-story house with a snow-covered roof and a chimney. A green circle highlights a tree trunk in the foreground, which is positioned in front of the house's east elevation.</p>
<p>Remarks</p>	<p>East elevation – no air leakage observed at electrical outlet and hose bib penetrations through wall. The cause of the thermal anomaly beneath the cantilevered concrete slab is unknown.</p>

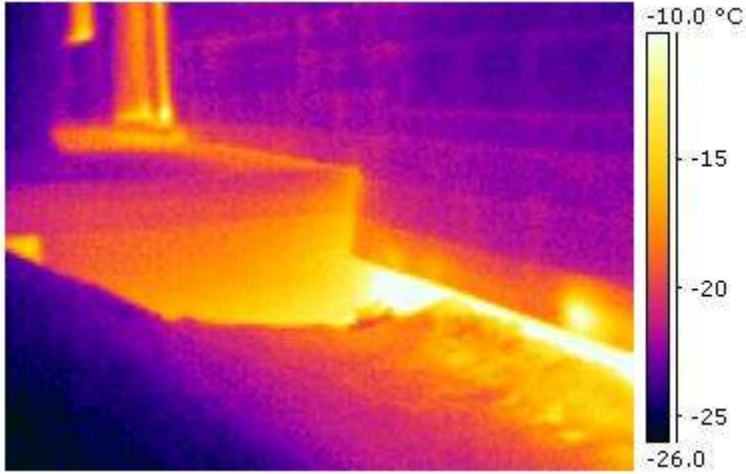
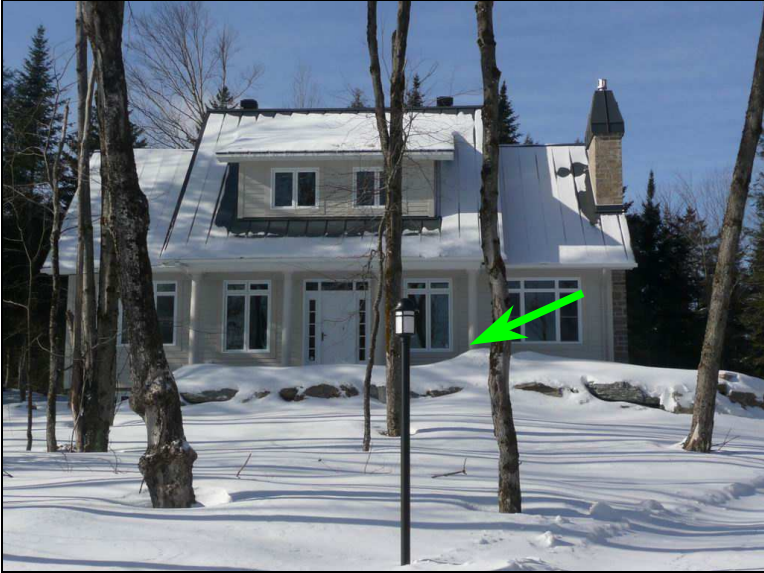
<p>Thermographic Image A11</p>

<p>Remarks</p>	<p>East elevation – The cause of the thermal anomaly beneath the cantilevered concrete slab is unknown.</p>

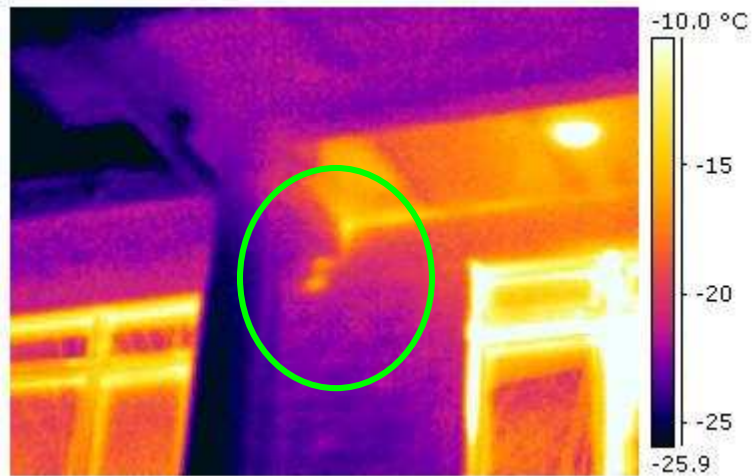
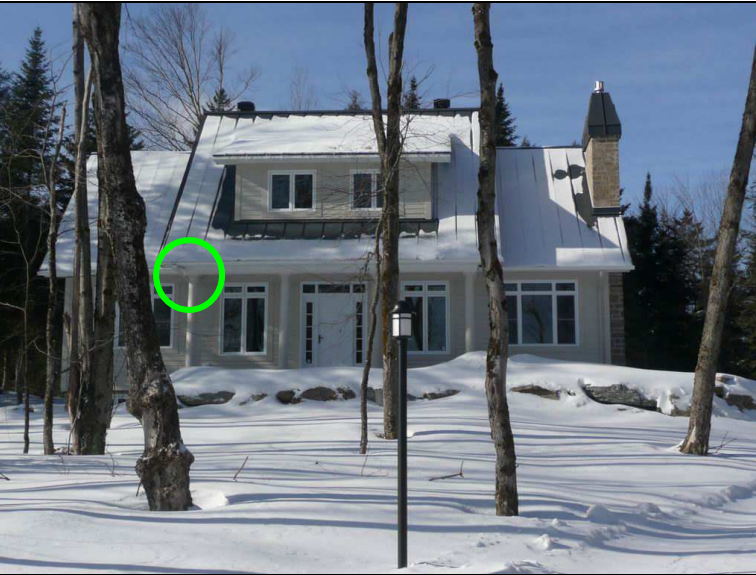
<p>Thermographic Image A12</p>

The thermal anomalies observed at the canopy at the main entrance are possibly due to air leakage occurring where the beams penetrate the envelope.

<p>Remarks</p>	<p>East elevation – suspected air leakage at canopy above main entrance.</p>

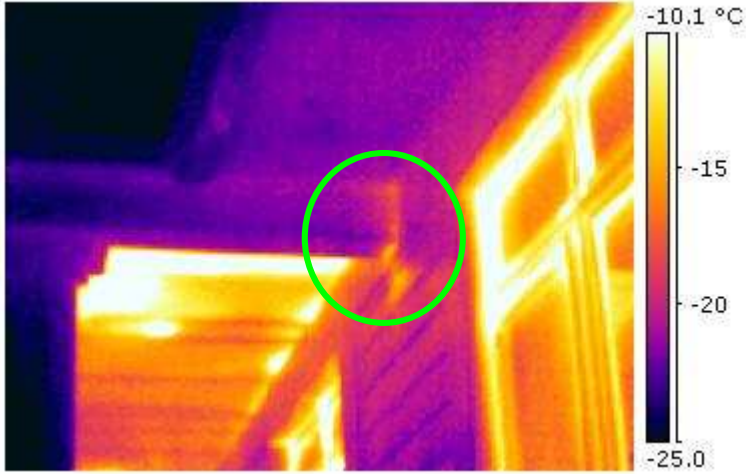
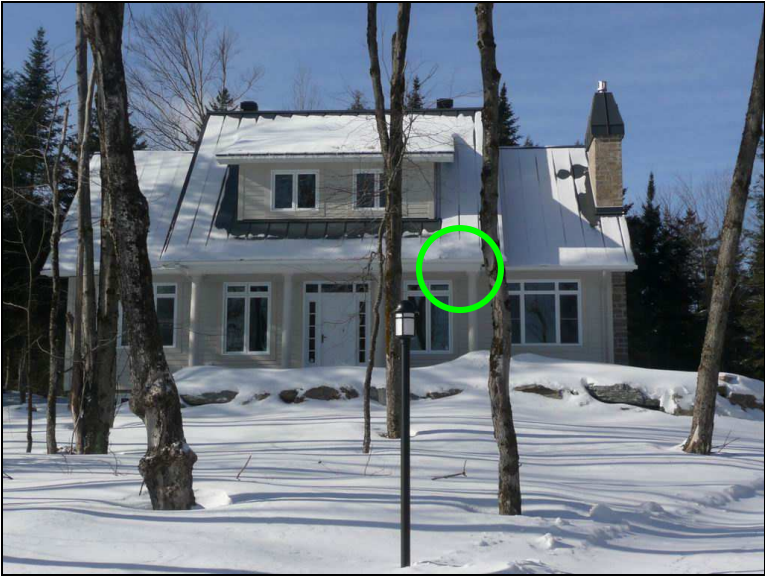
<p>Thermographic Image A13</p>

<p>Remarks</p>	<p>East elevation – suspected air leakage at canopy above main entrance.</p>

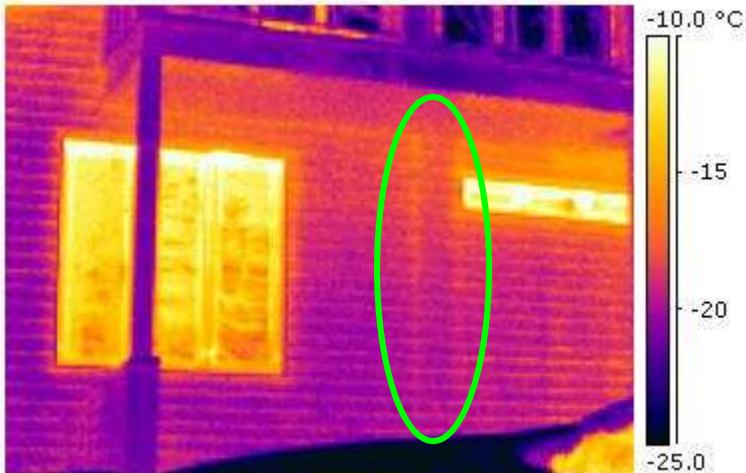
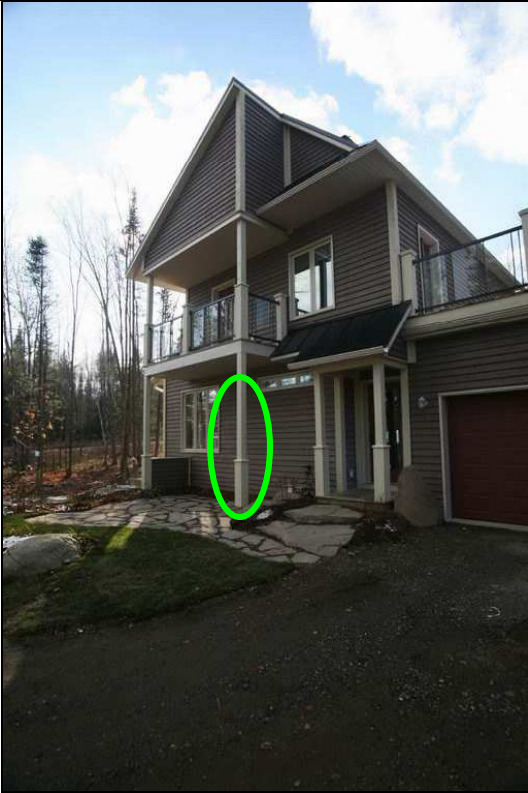
<p>Thermographic Image B1</p>

<p>A daylight photograph of a two-story house with grey siding and a gabled roof. A green oval highlights a vertical joint on the right elevation, corresponding to the thermal anomaly in the thermographic image.</p>
<p>Remarks</p>	<p>Right elevation - Minor thermal anomaly between windows. The cause of this anomaly is unknown but may be related to joints between the modular components of this home.</p>

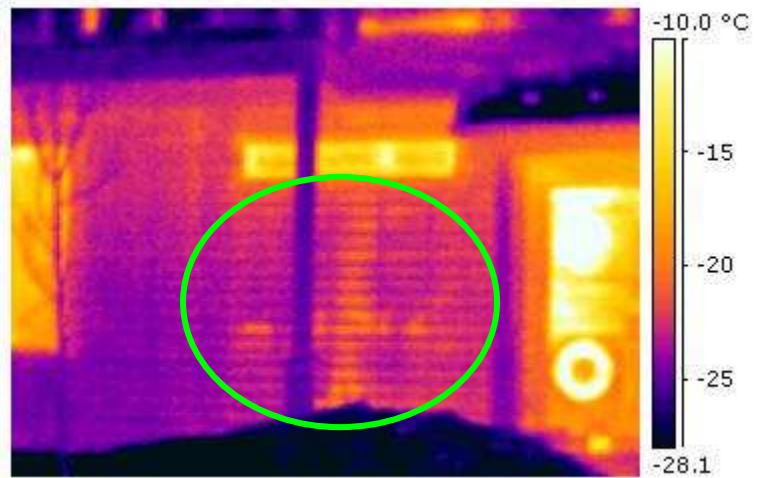
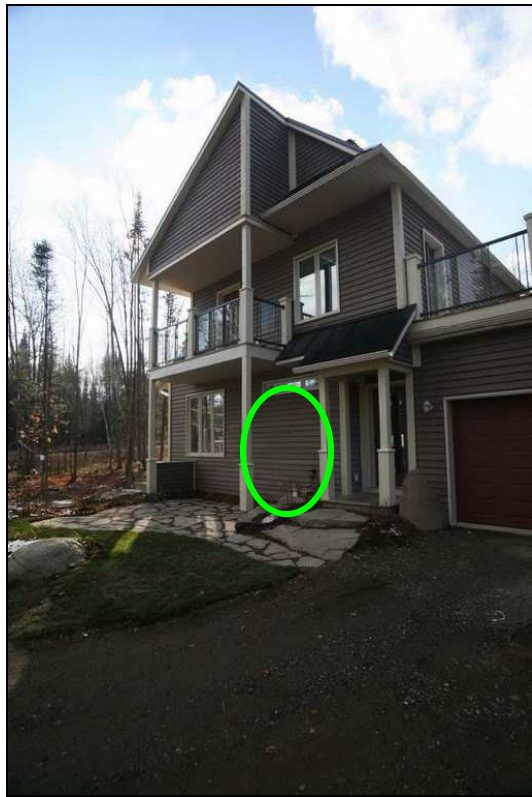
Thermographic
Image B2

Right elevation – Thermal anomaly below window. The cause of this anomaly is unknown.

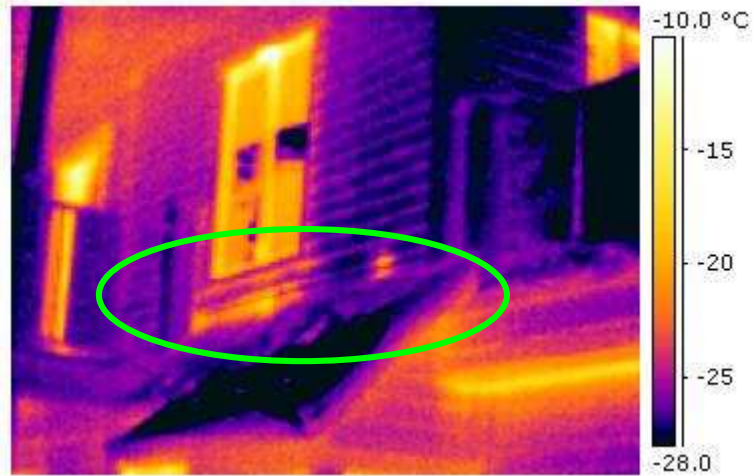
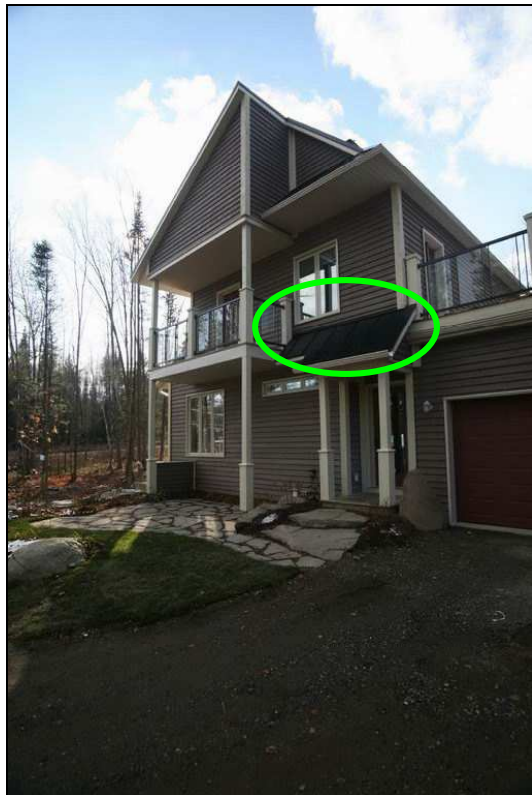
Thermographic Image B3

Right elevation – possible air leakage above canopy roof. The cause of this anomaly is unknown.

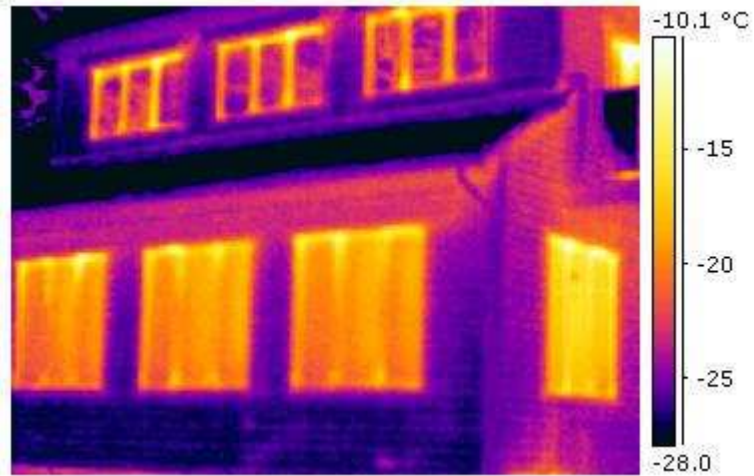
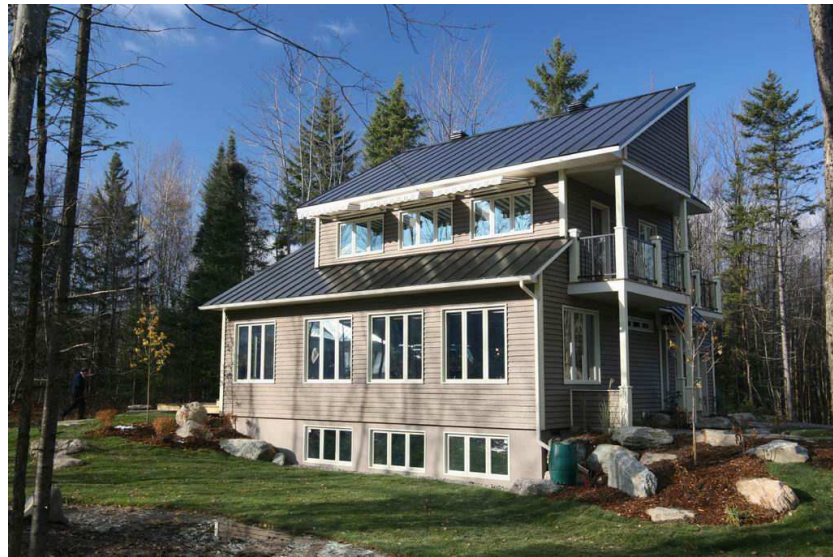
Thermographic
Image B4

Front elevation – Overall view, no thermal anomalies observed in this image.

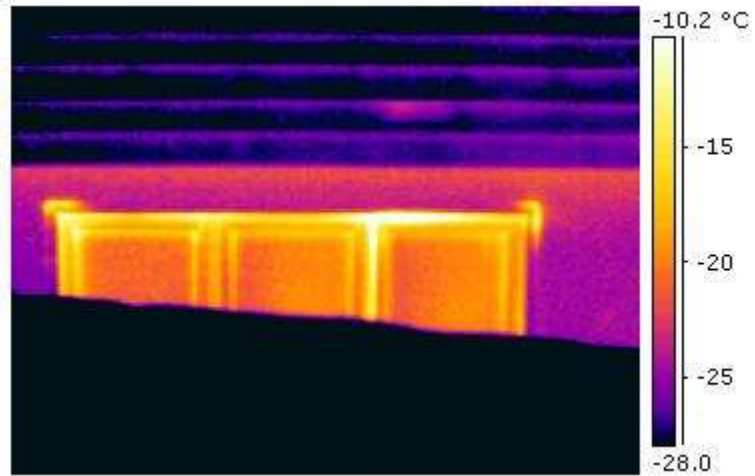
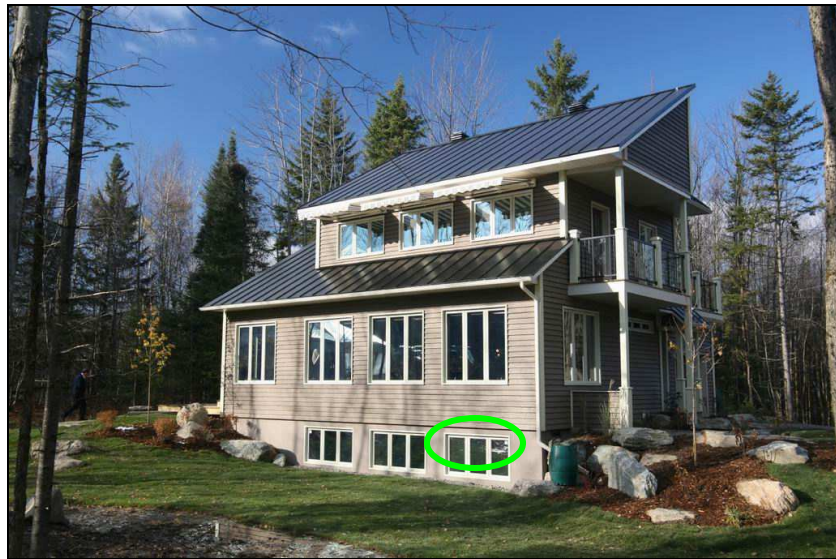
Thermographic
Image B5

Anomalies immediately adjacent to windows may be related to the installation of spray foam between the window frame and the rough opening.

Front elevation – suspected air leakage at top corners of windows.
This was typical at all three of these windows.

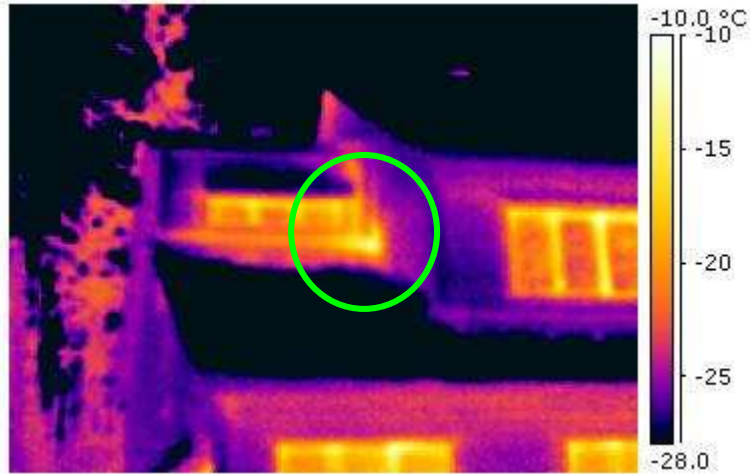
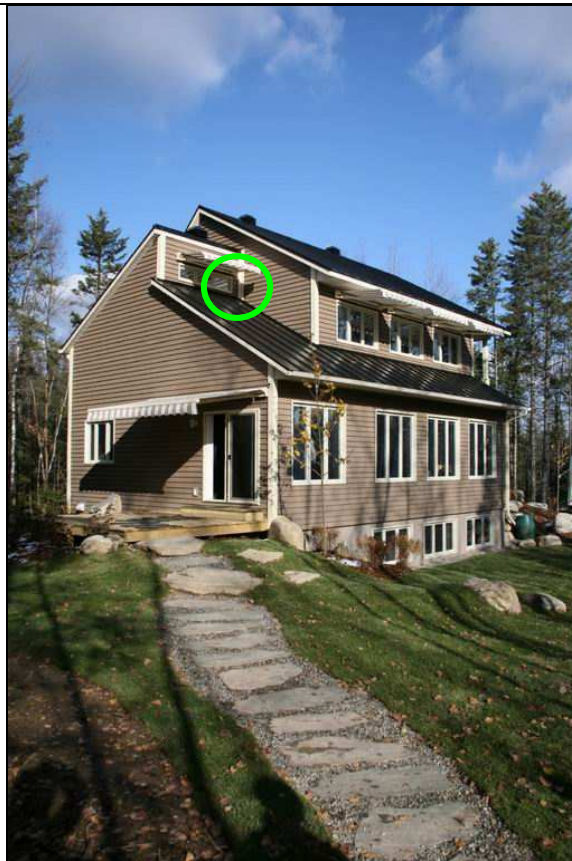
Thermographic Image B6

Front elevation – suspected air leakage at roof/wall interface on second floor. The cause of this anomaly is unknown but may be related to joints between the modular components of this home.

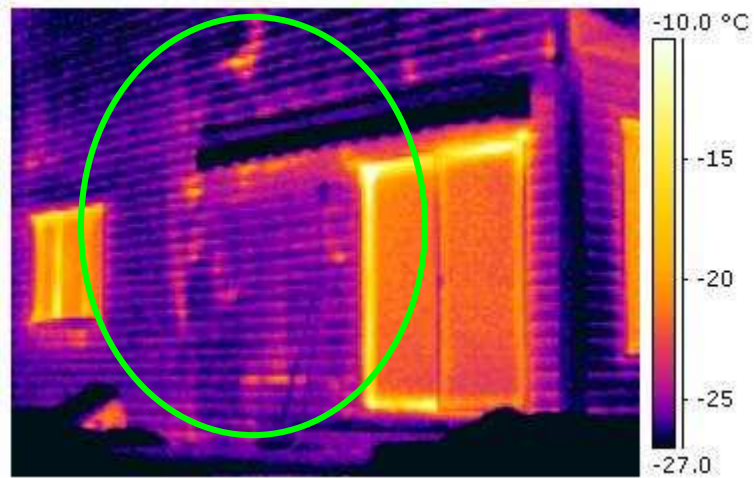
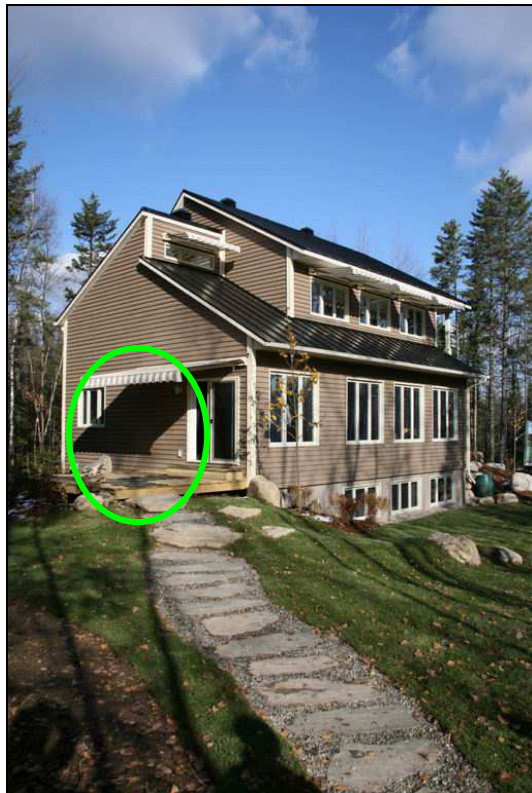
Thermographic Image B7

Left elevation – thermal anomalies observed left of patio door.
The cause of this anomaly is unknown but may be related to joints between the modular components of this home.

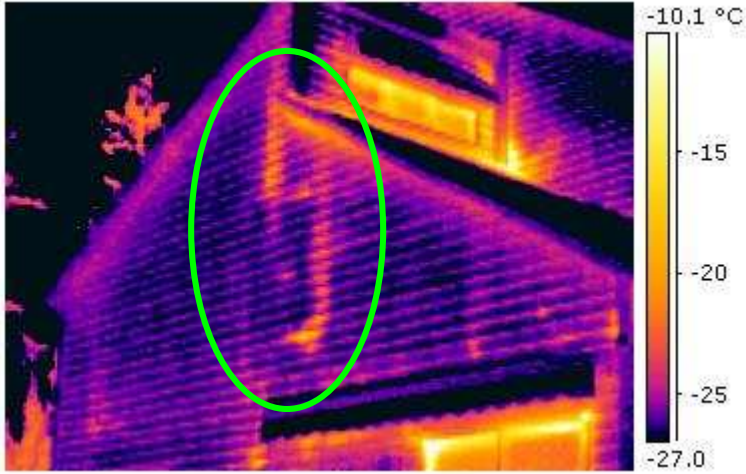
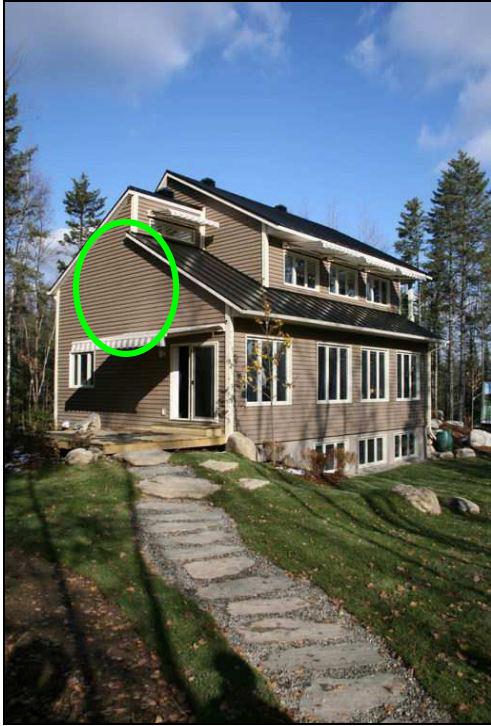
<p>Thermographic Image B8</p>

<p>Remarks</p>	<p>Left elevation – thermal anomalies observed above and left of patio door. This image also shows the suspected air leakage at the second floor presented in image B6. The cause of this anomaly is unknown but may be related to joints between the modular components of this home.</p>
